# Application of GIS - Spatial Analysis of the Status of Mangroves and Water Resources at Fanga'uta Lagoon Catchment(FLC)

Presented by,  
Savelina Pale and Sione Sunia

# Fanga'uta Lagoon Catchment (FLC)

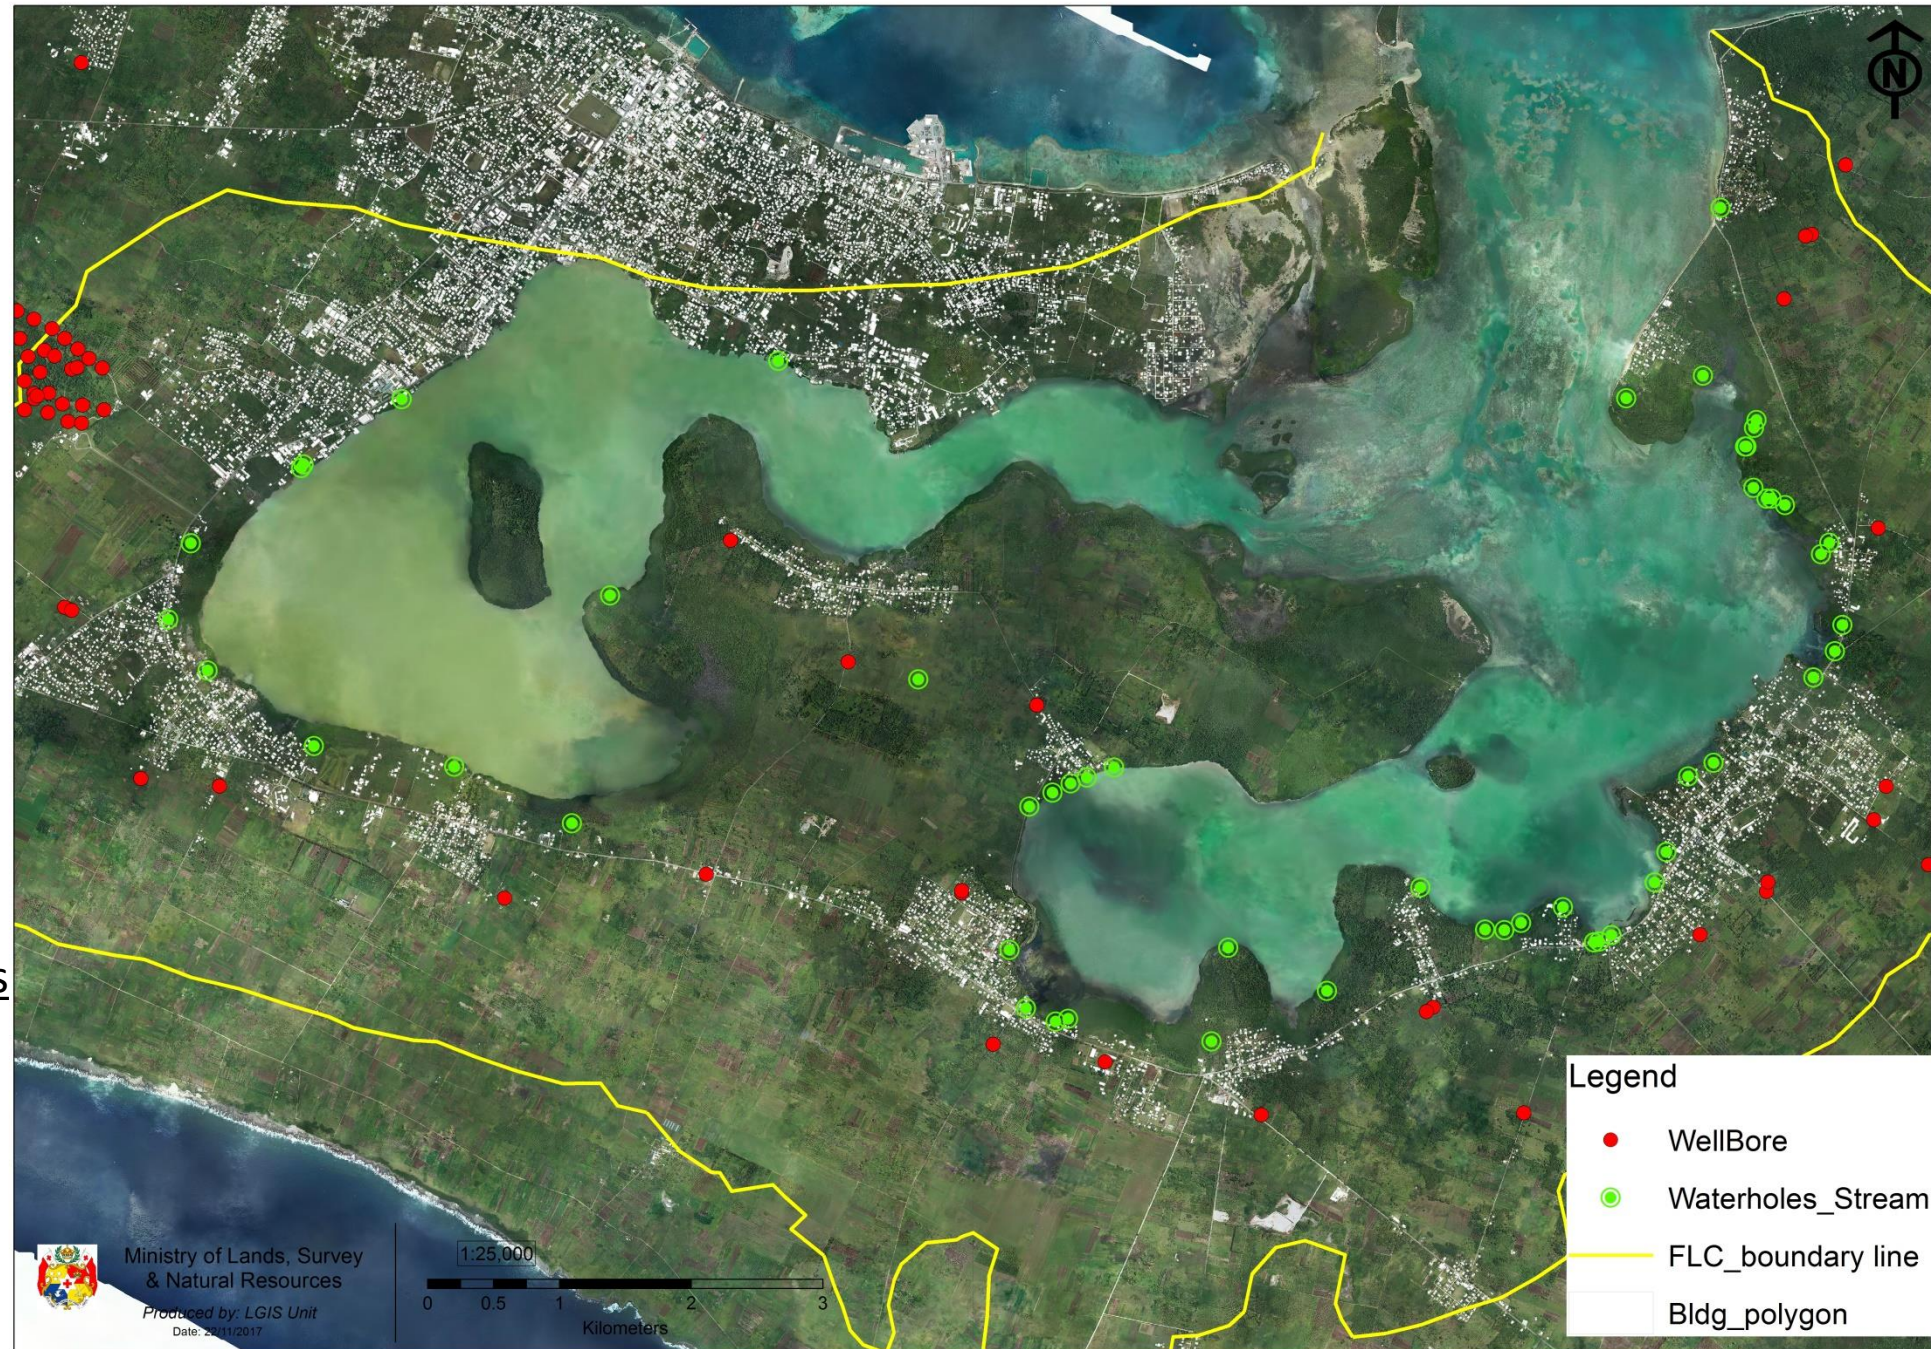
Determined by measure of

- Salinity of water
- Water depth
- Temperature
- Faecal Coliform (Bacteria count)
- Nitrate
- Nitrite
- Phosphate
- Ammonia

Conductivity were measure  
Using Solonist

Faecal Coliforms using reagents  
In the water lab

Green point – Spring Water  
Red point – Well Bores

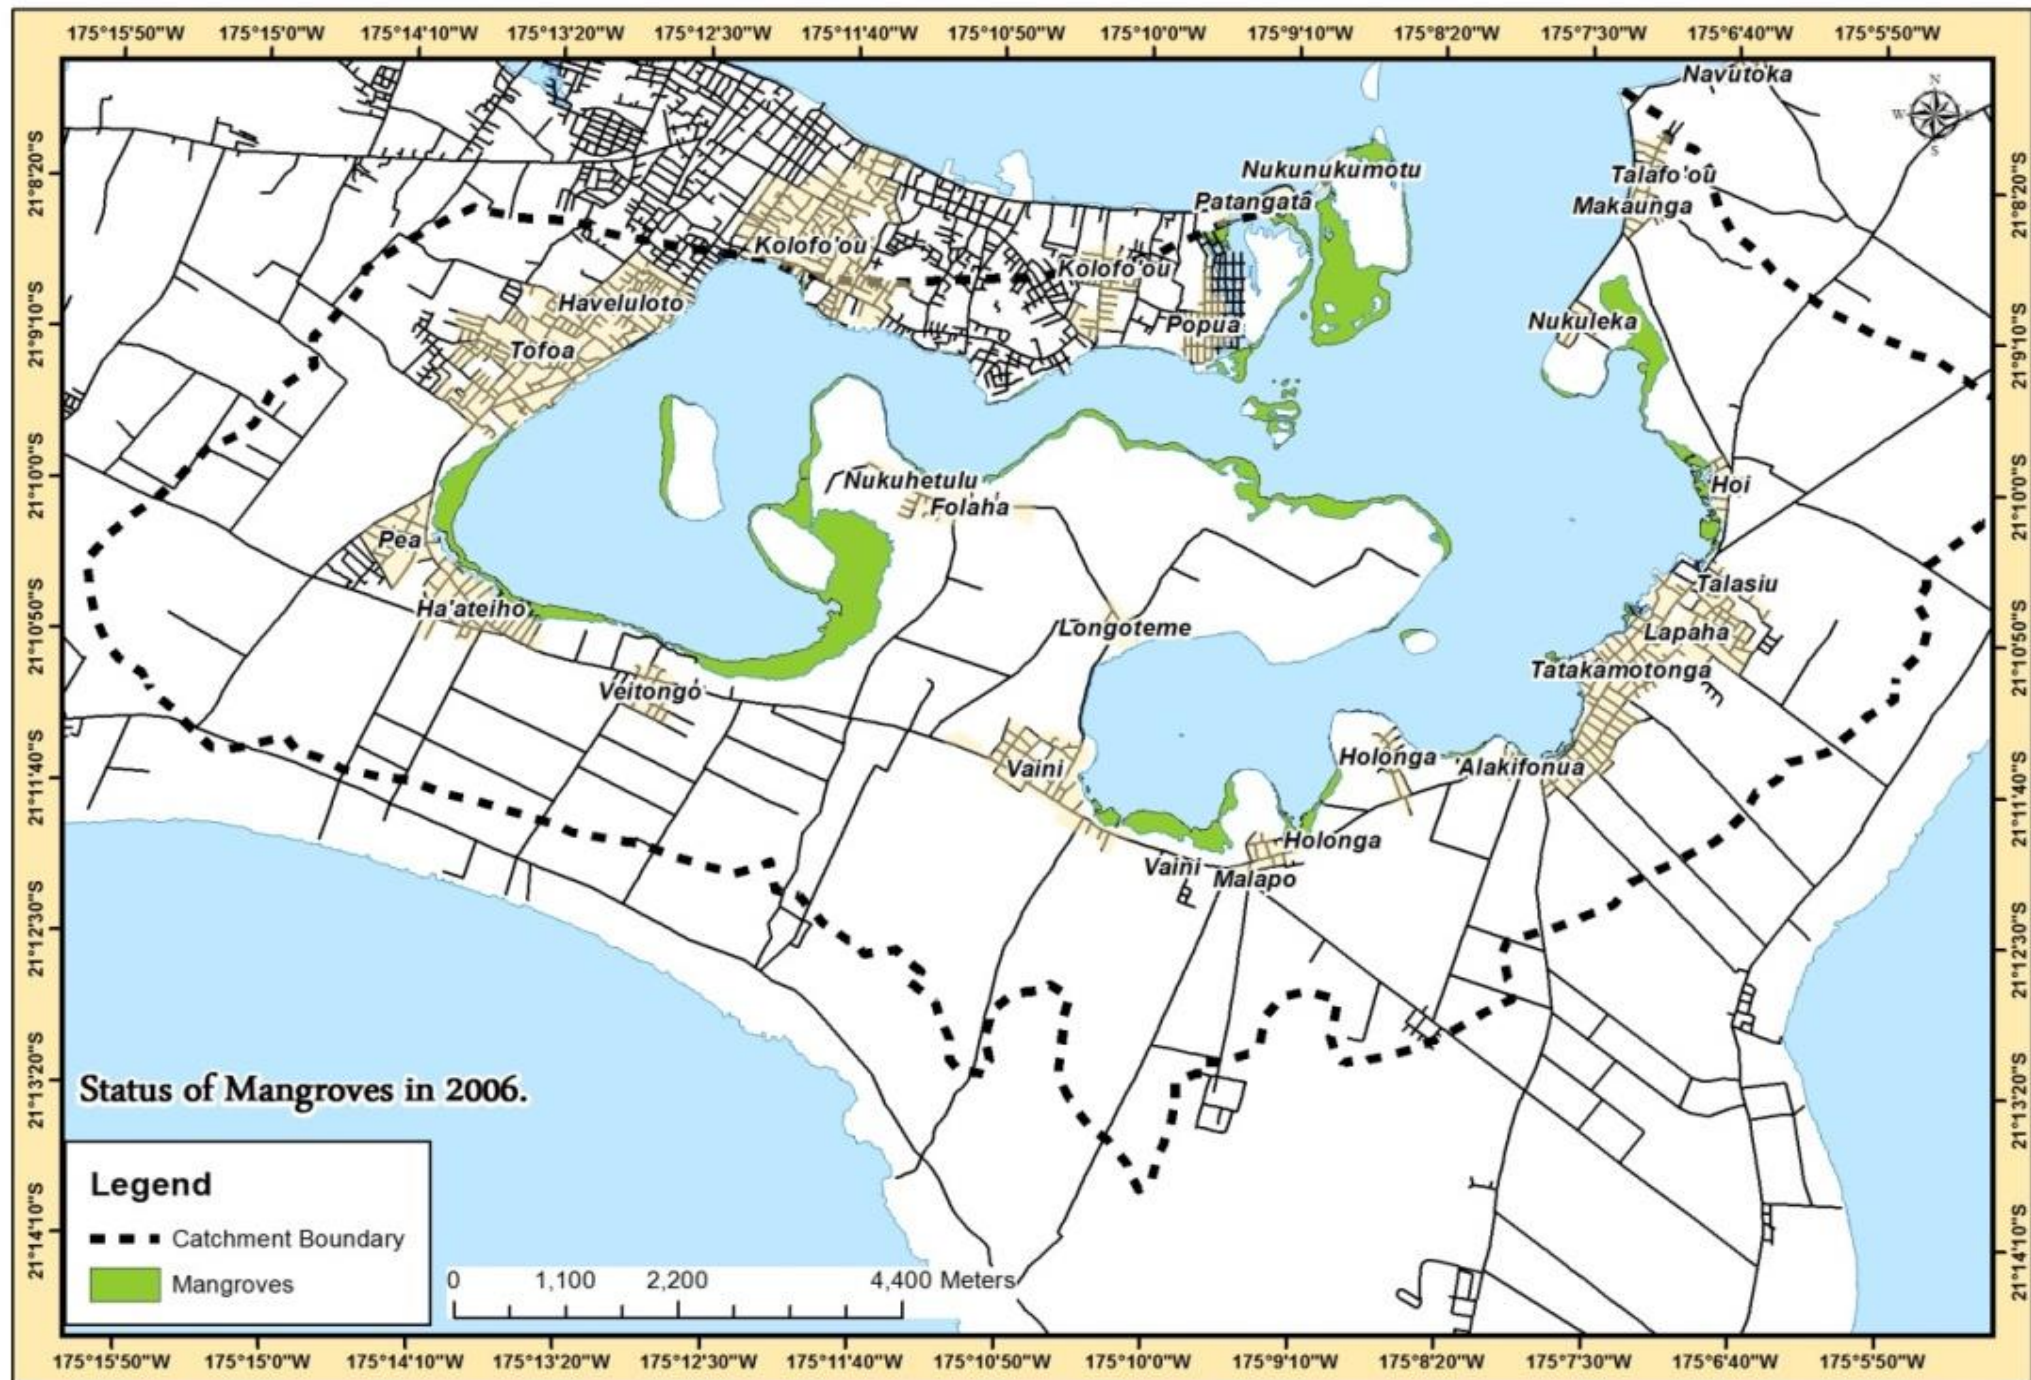
# Mangrove 2006

3 Sectors showing the  
loss of Mangroves.

- Popua
- Hoi
- Nuku
- Approximately  
417.69 ha of  
Mangrove  
at site

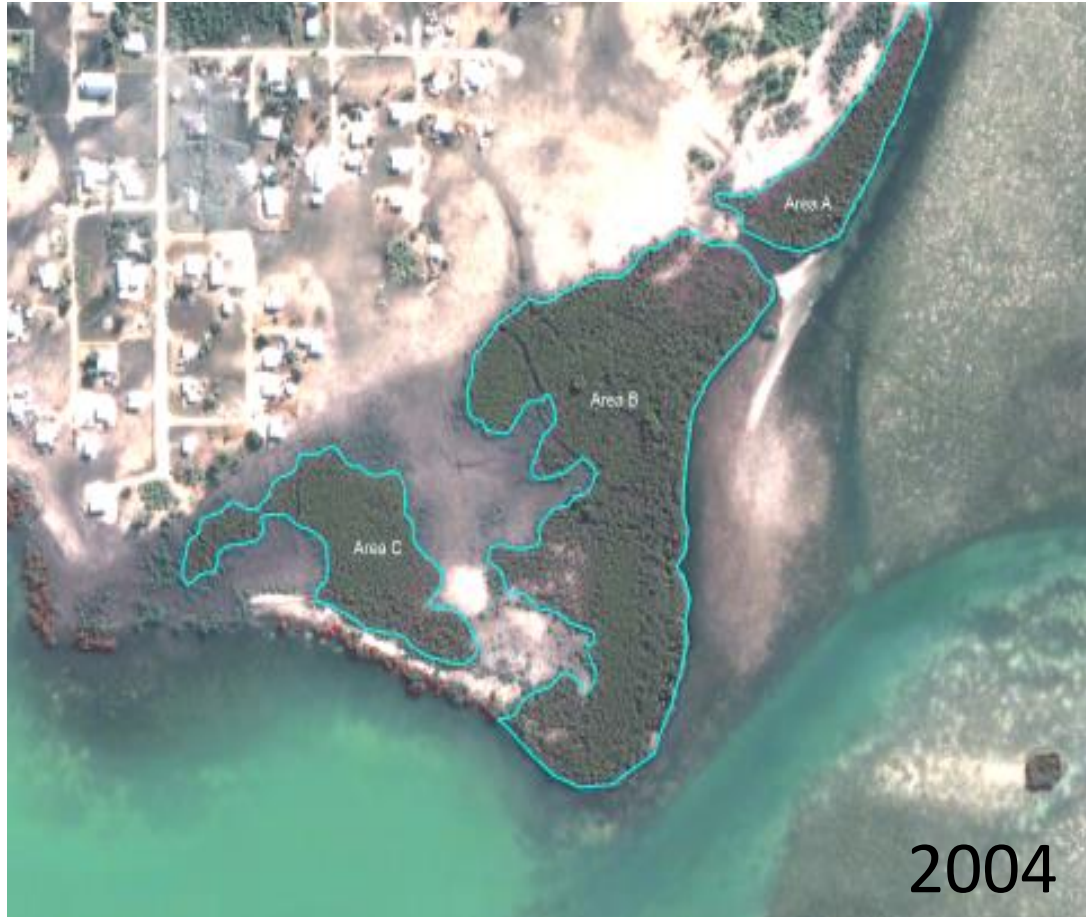
Sector I

Mangrove loss – Approx 48.7 %

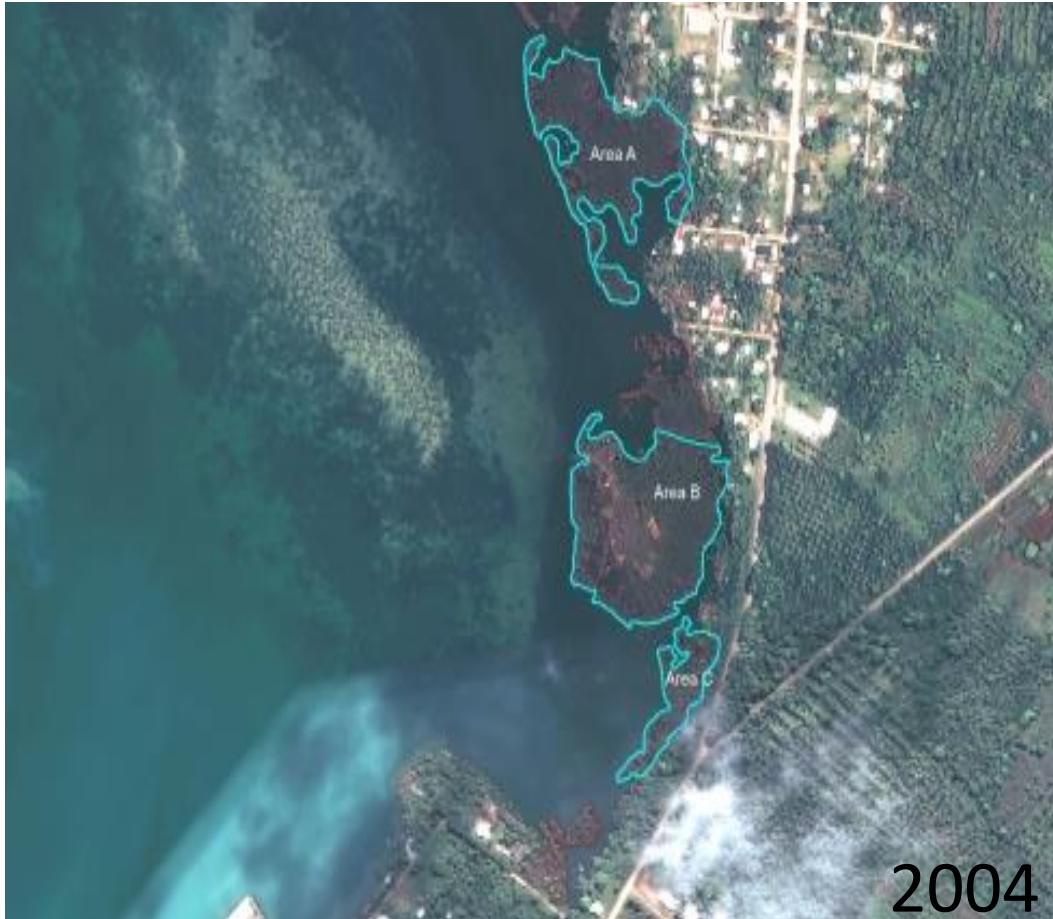
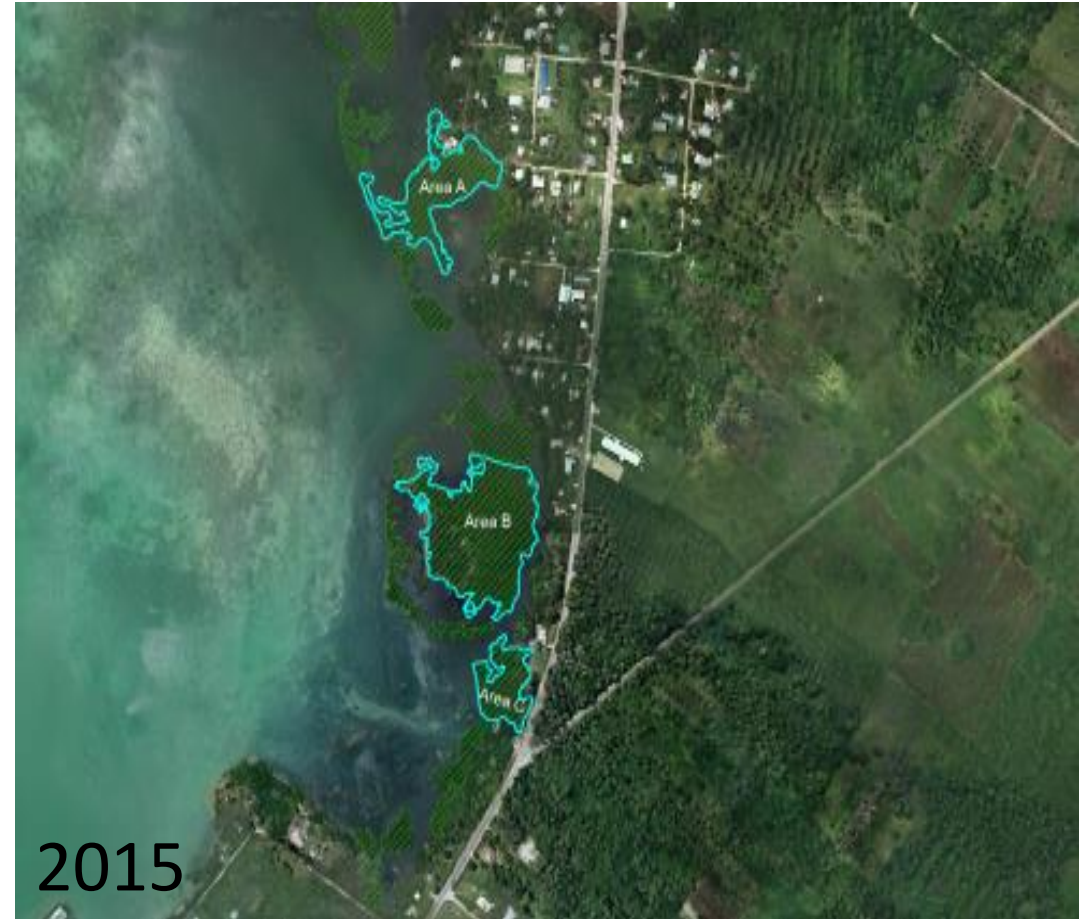
Sector II

Mangrove loss – Approx 30.7 %

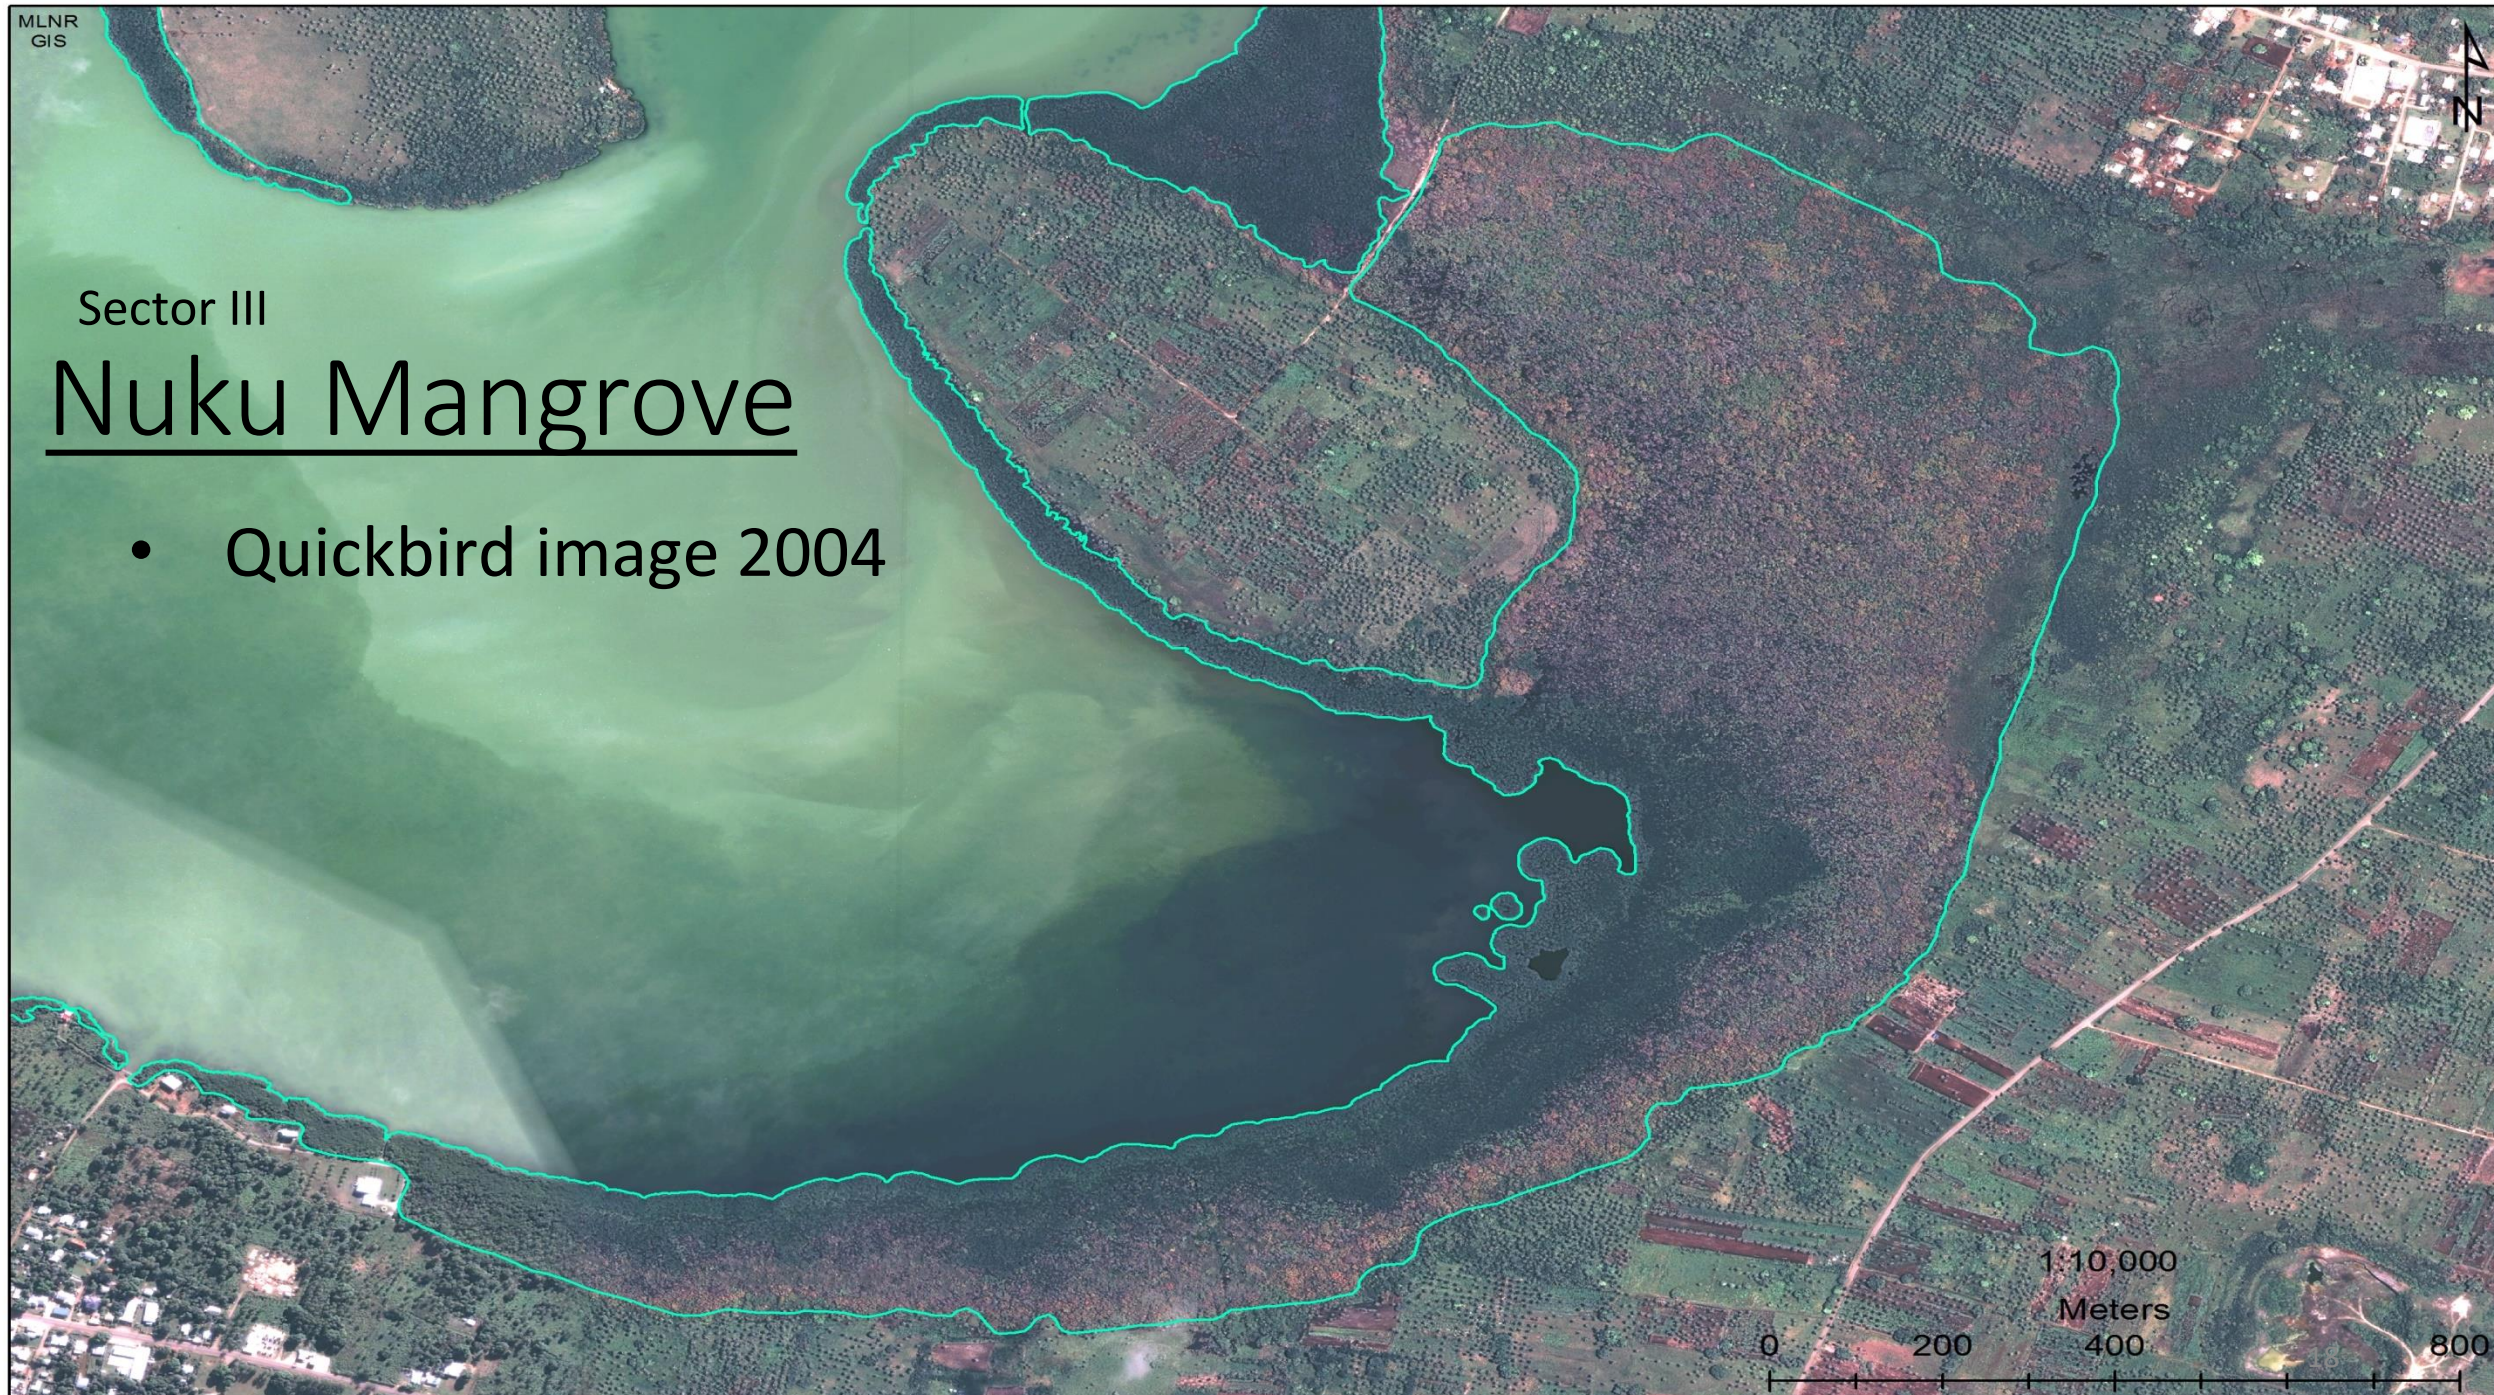
Sector III

- Quickbird image 2004

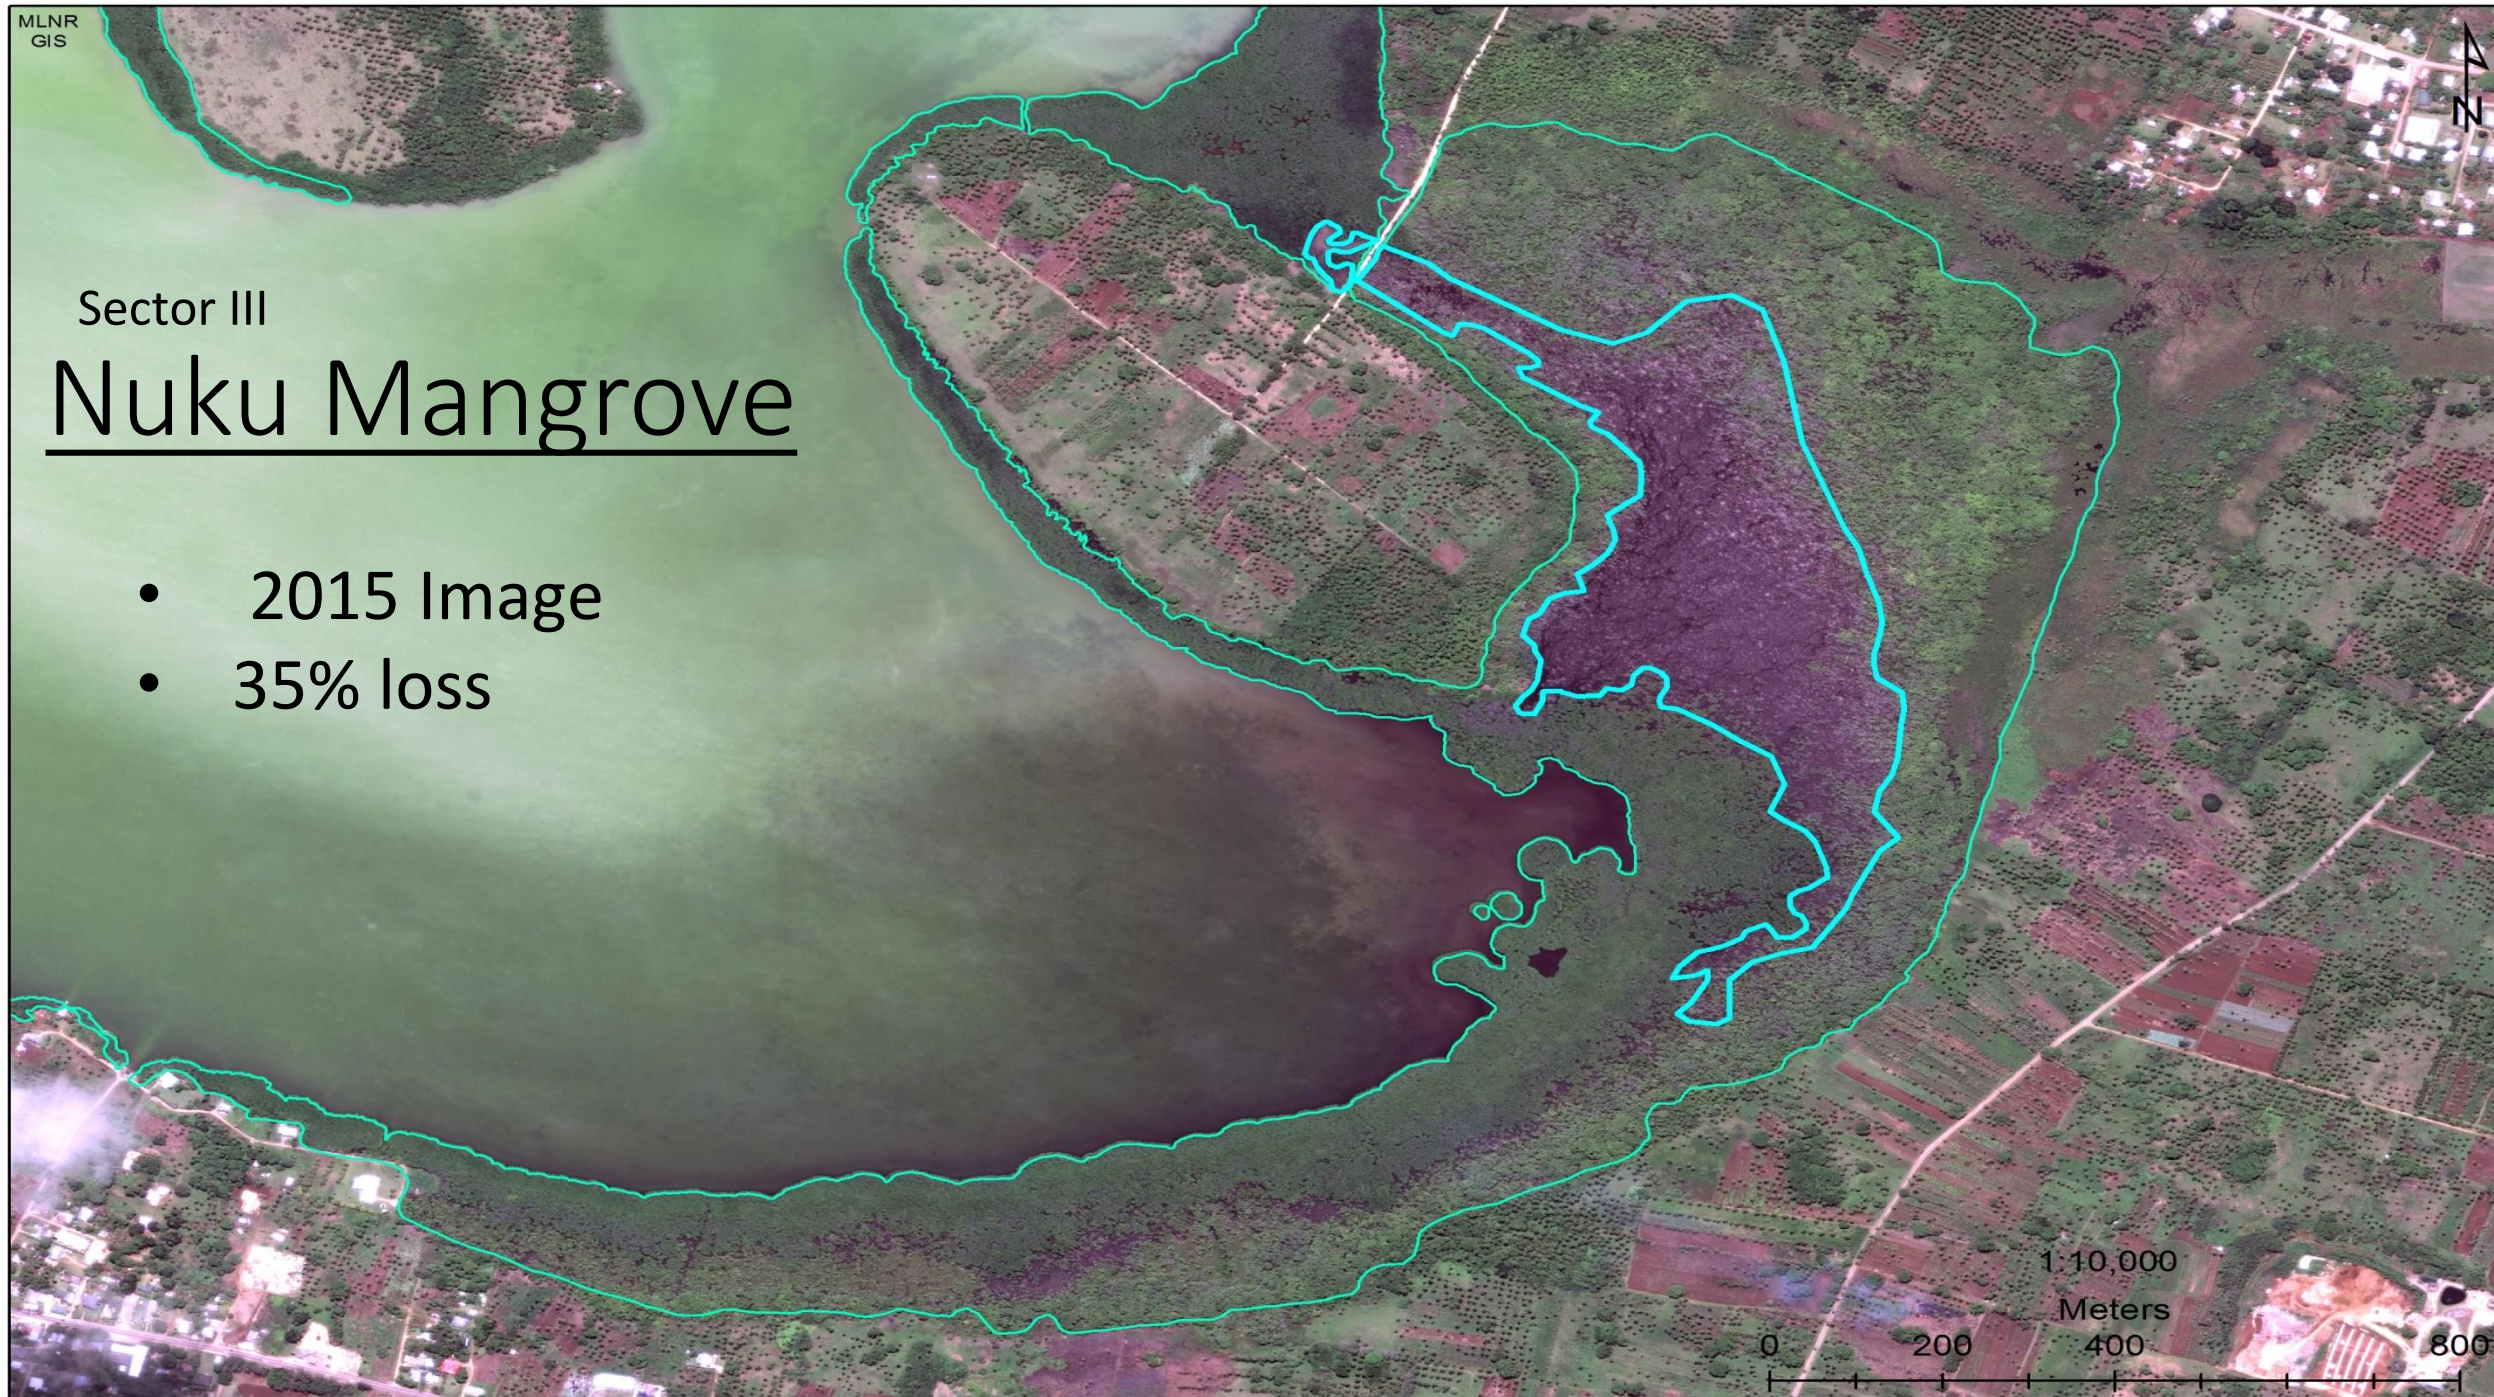
Sector III

- 2015 Image
- 35% loss

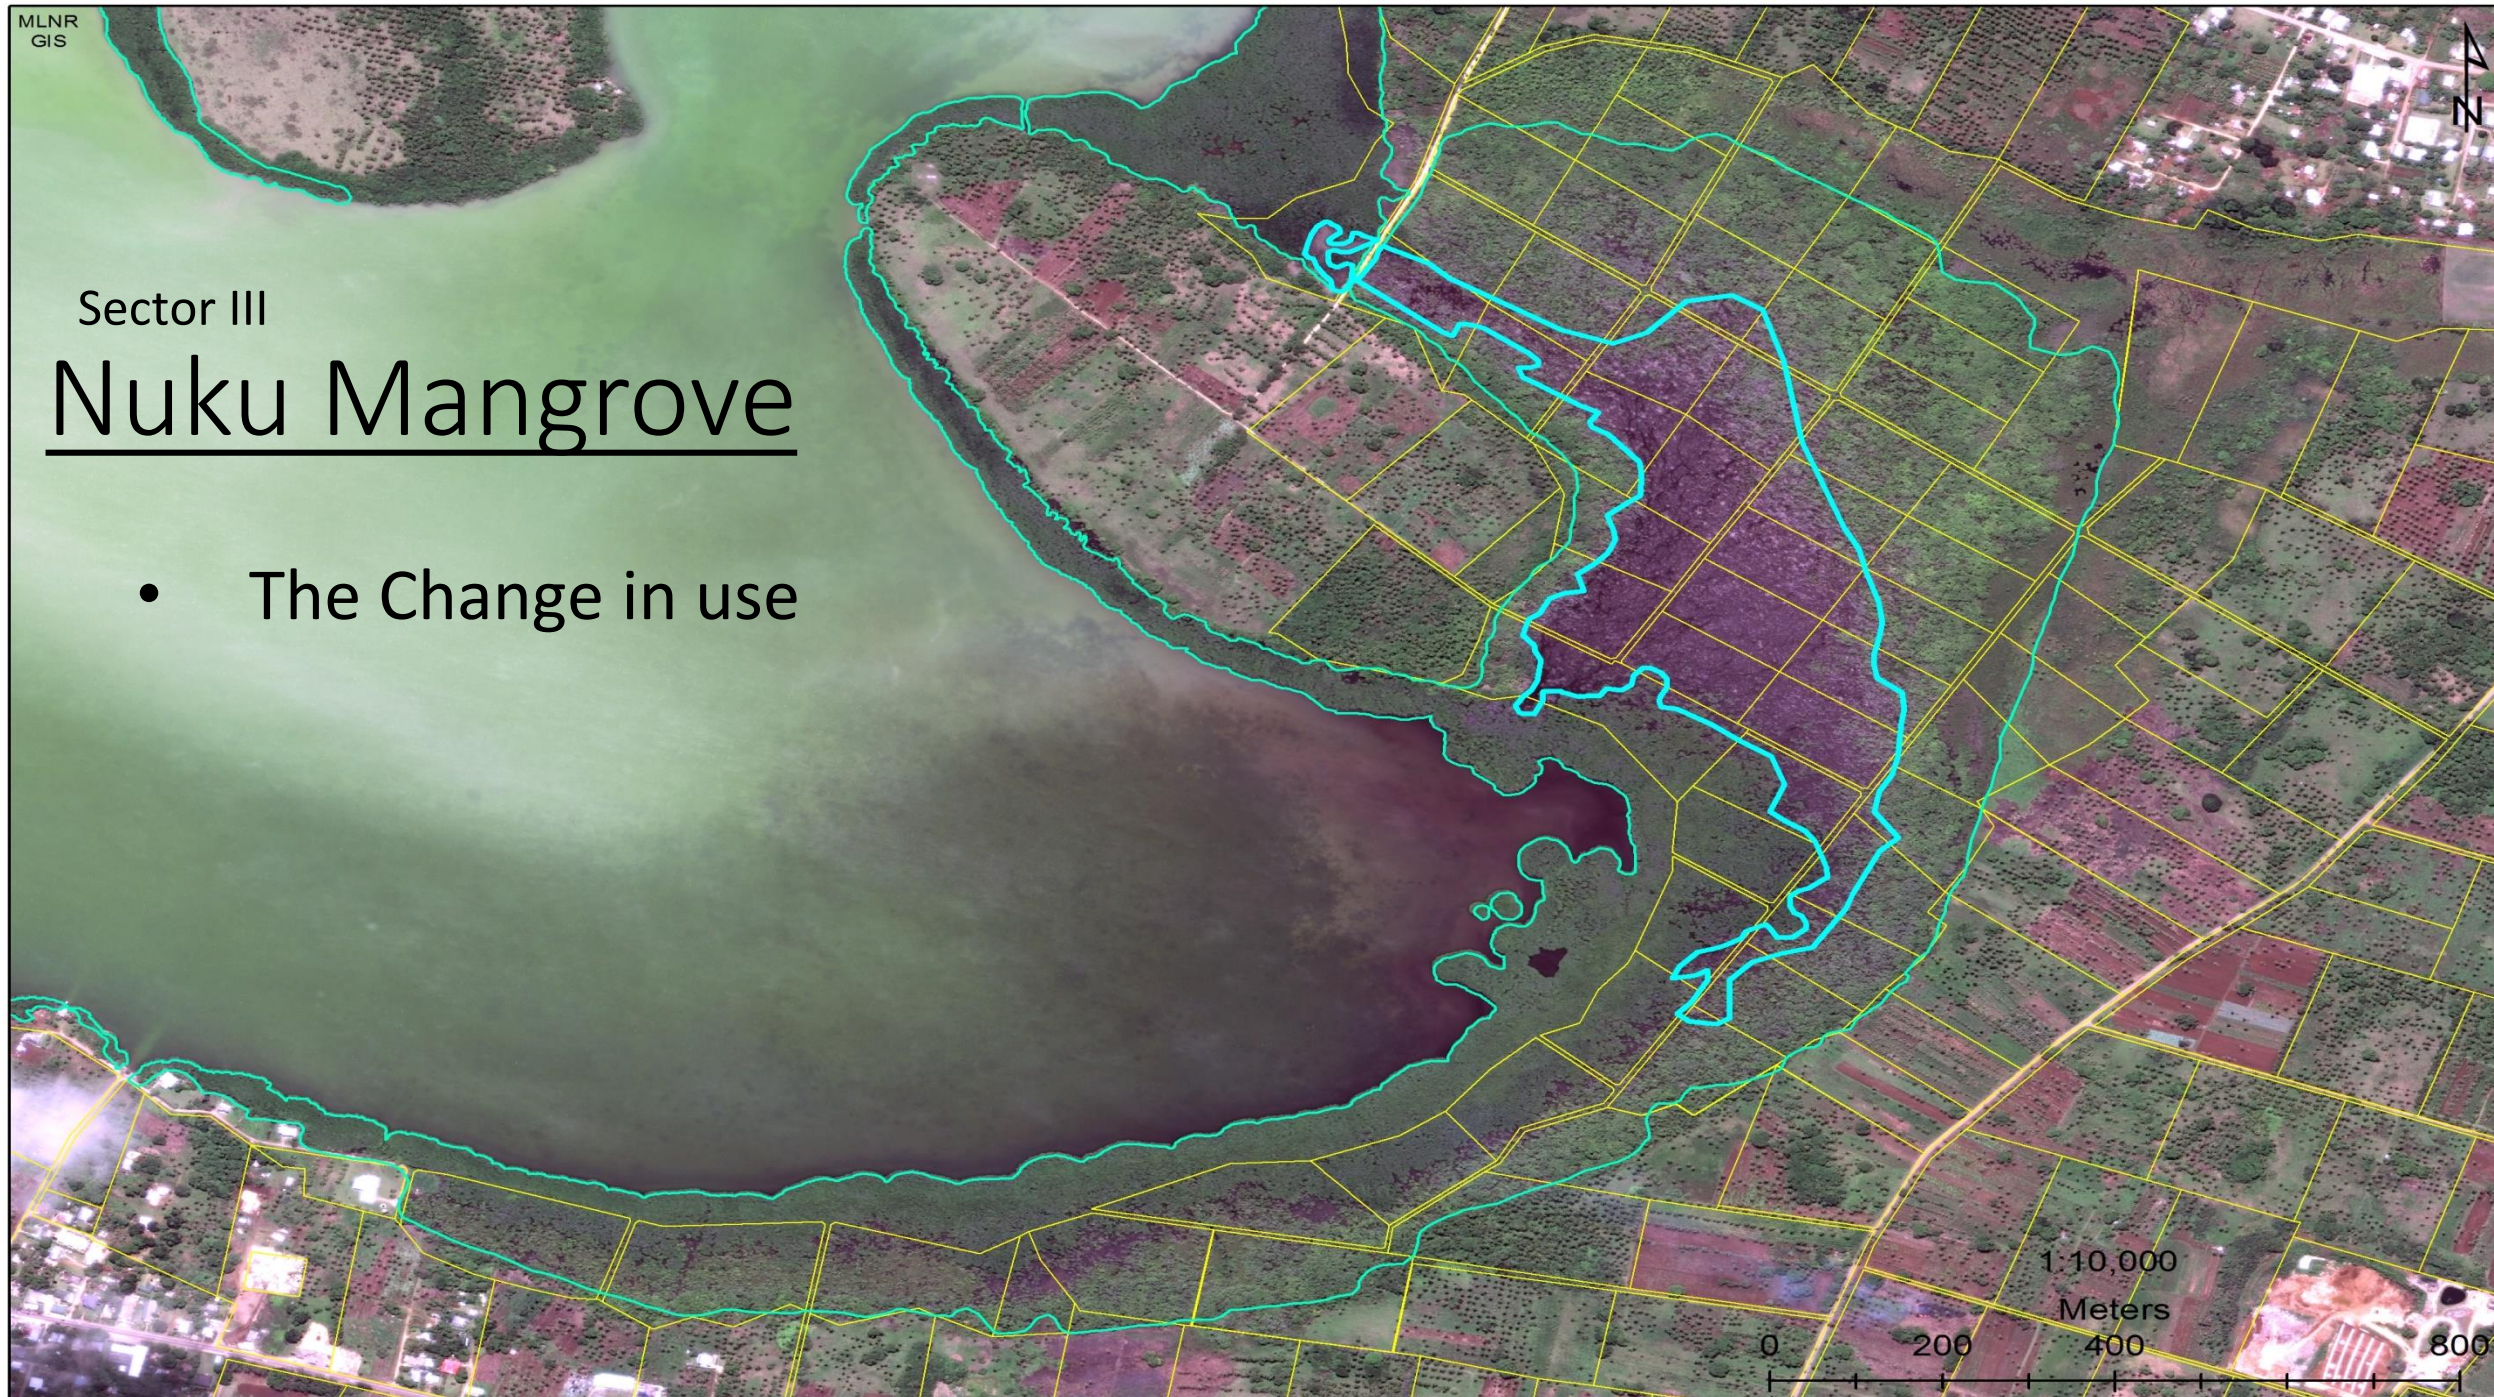
Sector III

- The Change in use
